Portage Creek Sediment Remediation Project Kalamazoo, Michigan

Pre-Sediment Removal Structure Feature Assessment
Removal Areas SA1-A, SA1-B and SA1-C

F&V Project Number: 809930
May, 2013

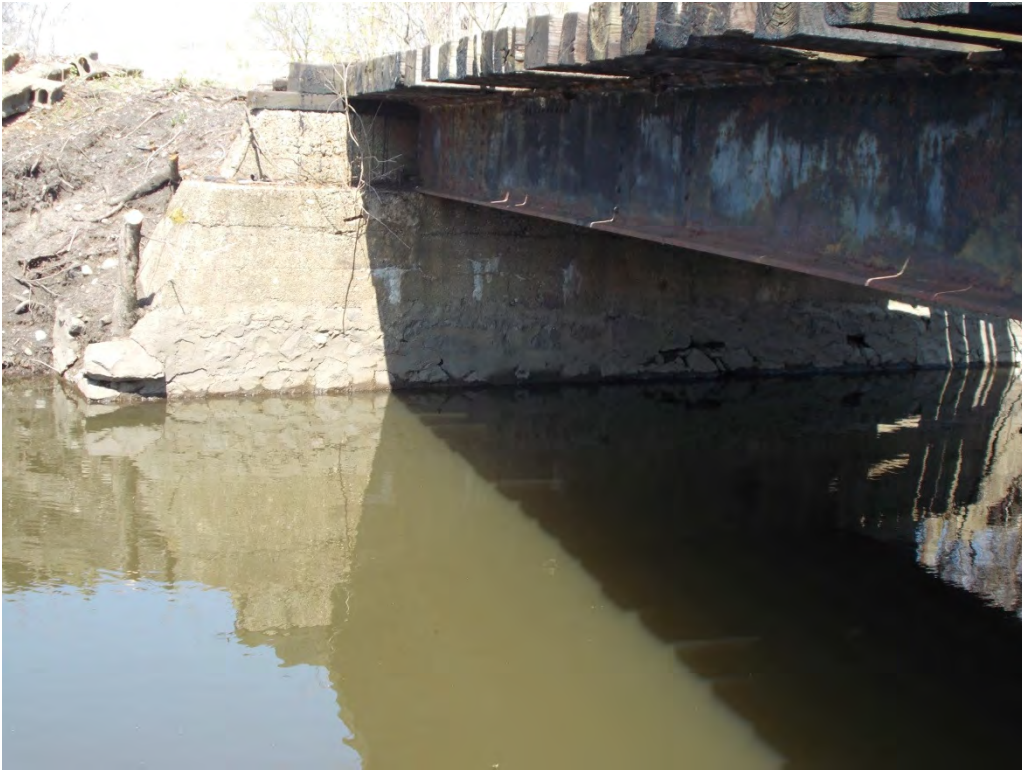
- The upper concrete abutments have moderate weathering. The lower stone abutments have grout voids, many of which have been patched. No undermining was detected.
- The steel beams have minor to moderate surface corrosion.
- Timber ties have severe to critical rot and section loss.
- The timber railing has a failed top plate the entire east half of the structure.
- The structure carries two sets of steel tracks, as it is located near a switch.
- Heavy brush is encroaching on the structure.
- Moderate to severe slope/bank erosion was noted all 4 quadrants. The channel spans abutment to abutment with no bank in place at the structure.

Corrosion on fascia beam

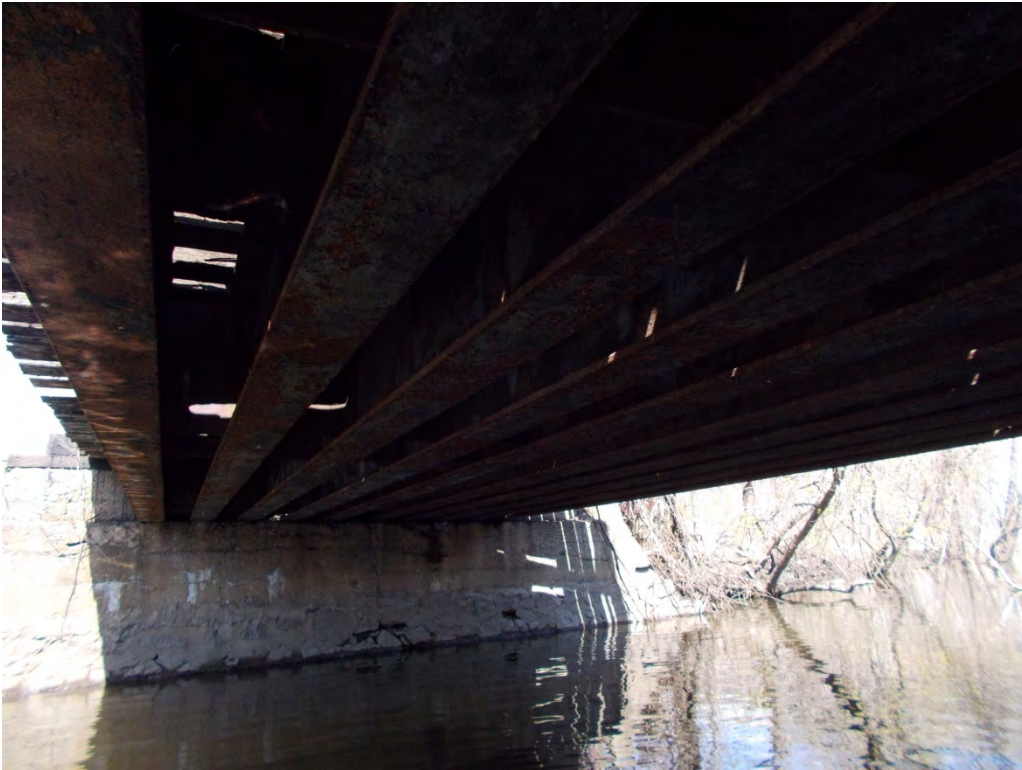
Corrosion on steel beams

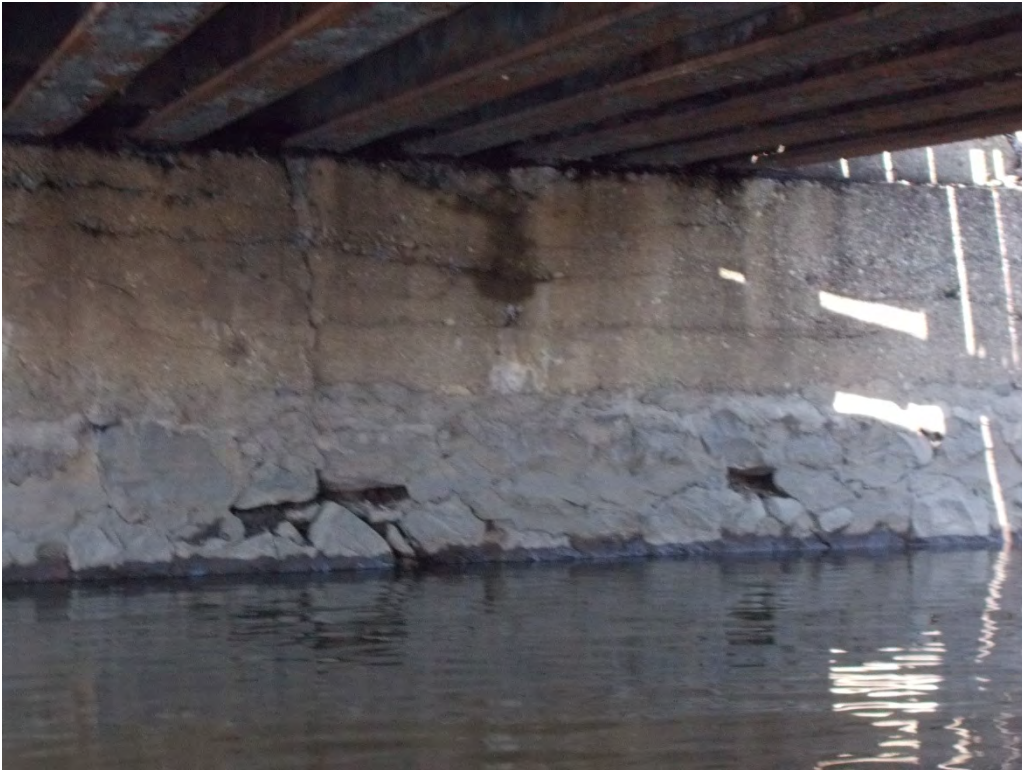
Voids in stone foundation

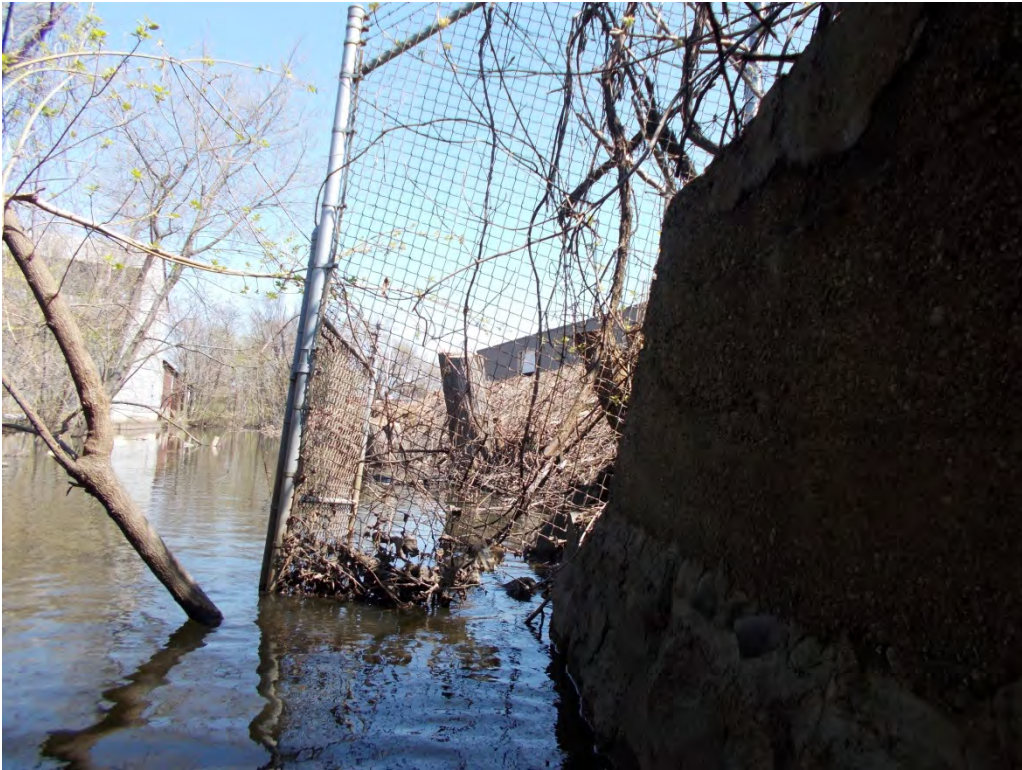
Fencing in northeast quadrant

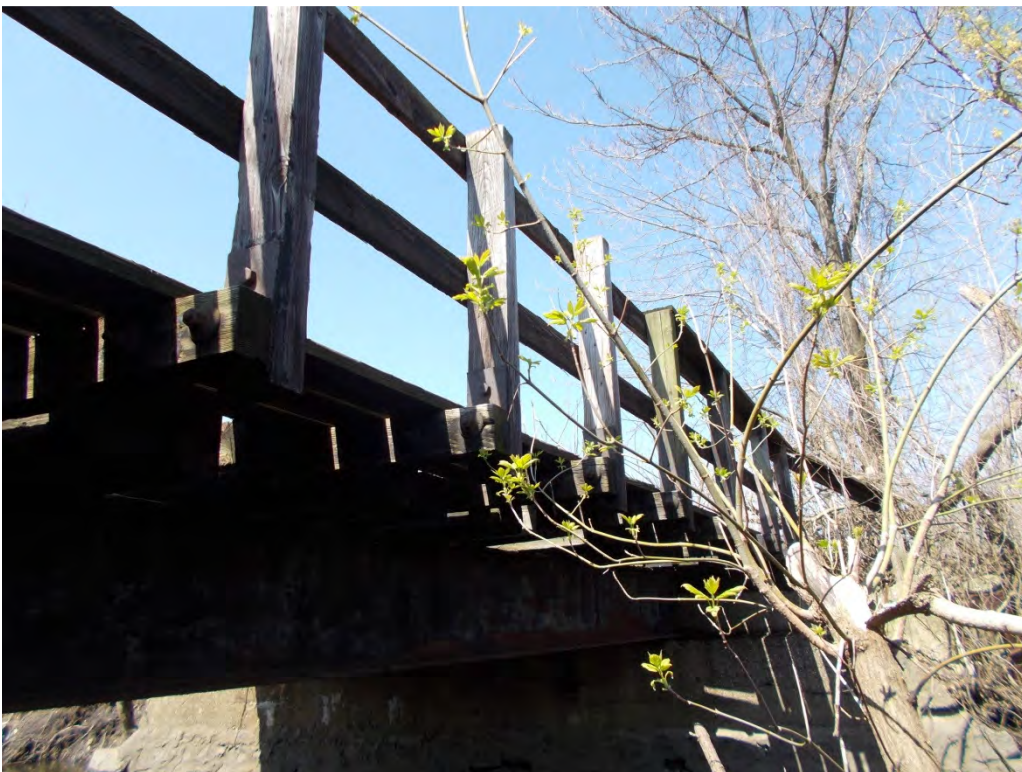
View of timber railing from channel

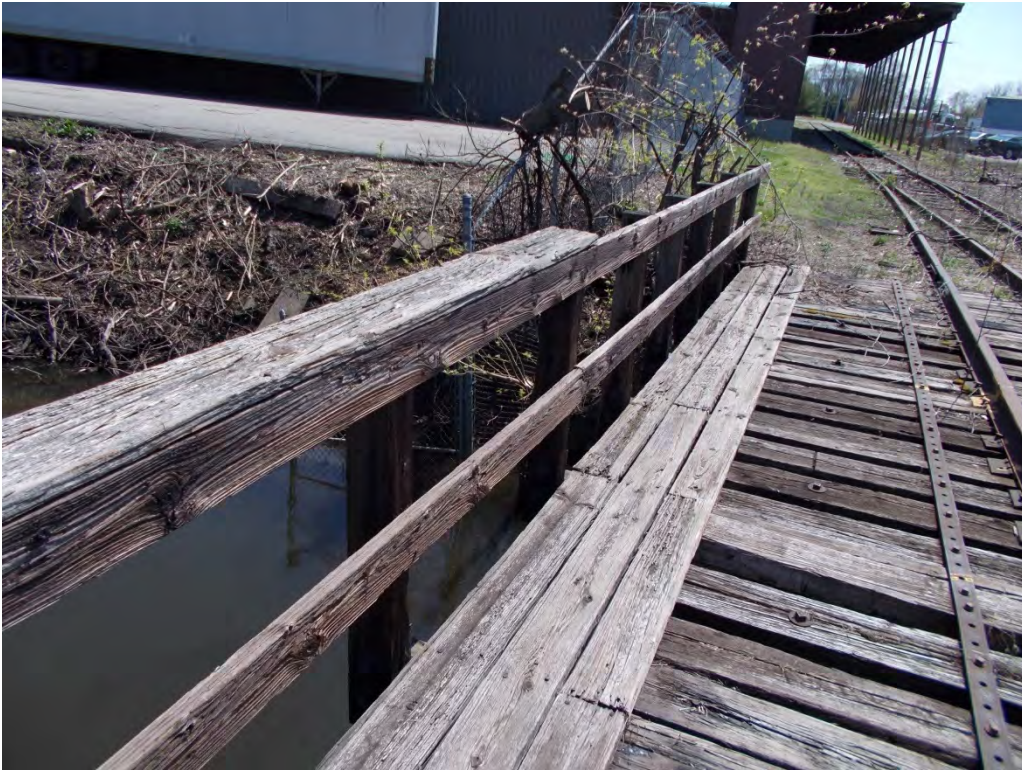
Failed top plate on timber railing
